# Property Inspection Report

**Report Number: HI-2019-0718-Goewey**

1292 Hickory Hound Ears  
Boone, North Carolina 28607

Date of Inspection: Thursday, July 18, 2019

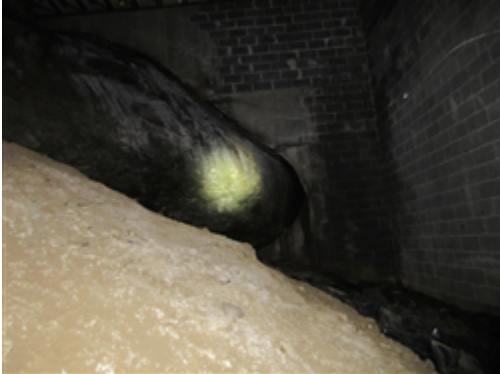
##### (A1 - 1.1 ) Main House

Foundation walls in the crawl space had evidence of moisture in the following areas ( photo examples numbered for reference:

1- Garage space side boulder wall.

Direct water penetration damages the foundation, the wood structure, and creates an undesirable environment in the crawl space areas that encourages insects and or fungal growths such as mold/mildew.

Repairs are needed to prevent water penetration. Water in the crawl space indicates an absent or damaged waterproofing and foundation drain system. Repairs are needed to prevent water penetration. A licensed general contractor should be consulted for further evaluation to determine the source of the moisture and to make necessary repairs.

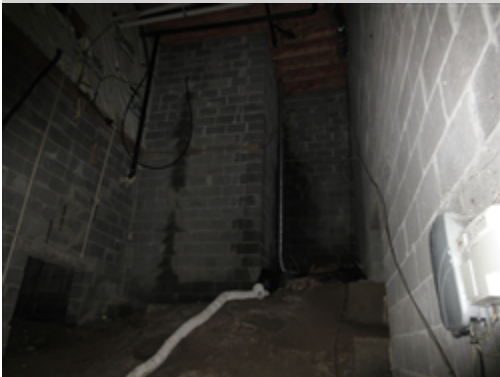
##### (A1 - 1.2 ) Main House

2-front wall dryer area location above

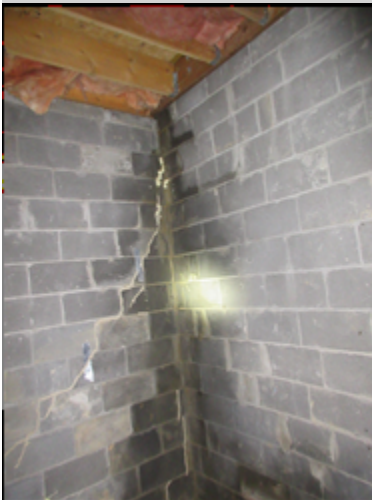
##### (A1 - 1.3 ) Main House

3- Front wall center section corner

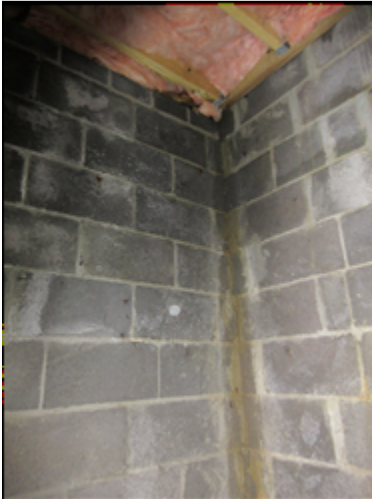
**(A1 - 1.4 ) Main House**

3a- additional front wall center section corner

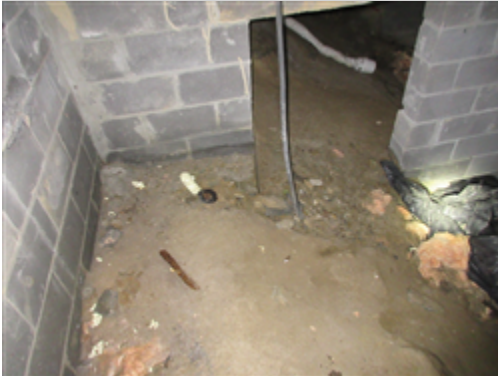
**(A1 - 1.5 ) Main House**

The floor of the crawl space has very poor vapor barrier coverage and the humidity in these chambers is elevated. A elevated moisture condition in the crawl space can contribute to damage to the insulation installation. A general contractor specializing in basement systems should be consulted to evaluate the areas and make recommendations on remediation solutions.

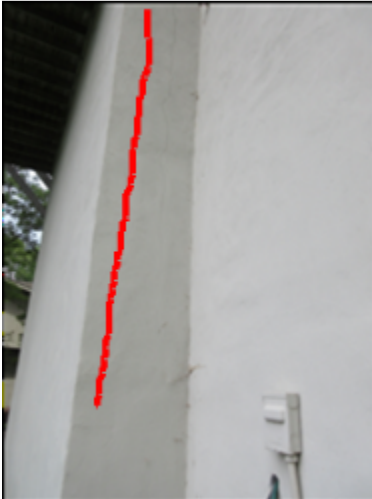
**(A1 - 1.6 ) Main House**

Vertical and stepping cracks were noted in several areas of the exterior basement walls. The purpose of the basement wall is to support the home, retain the outside soil and prevent water penetration into the structure. When basement walls crack, the crack indicates a deficiency in the foundation, footing, or supporting soil that can change and worsen if it progresses over the life of the home. An engineer should be consulted to determine the significance/cause of the cracks and outline any necessary repairs. See two examples of areas below.

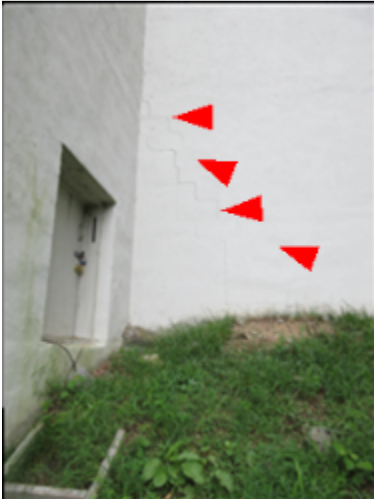
**(A1 - 1.7 ) Main House**

Stair step cracks. Light can be seen from inside the crawl space.

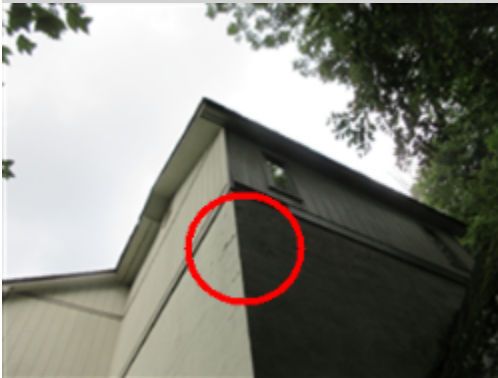
**(A1 - 1.8 ) Main House**

Corner crack located above on the garage foundation wall.

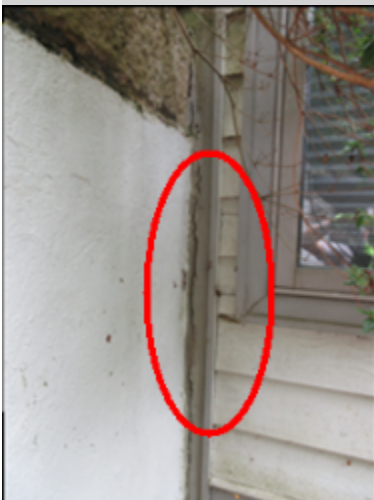
**(B1 - 2.1 ) Main House Front - Right side**

The exterior siding of the home was found to have areas of decay in the trim, siding and window frame. A licensed general contractor should be consulted for a complete evaluation of the exterior of the home to determine the extent of the damage to the siding, trim, and underlying components to ensure the weathertightness of the system.

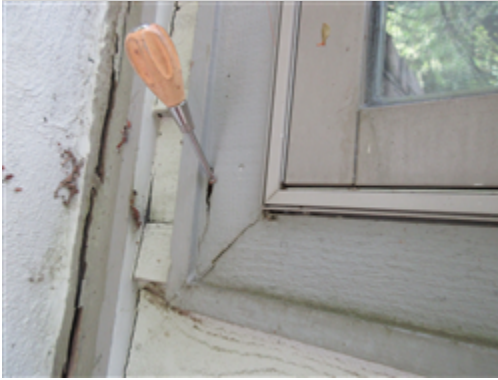
**(B1 - 2.2 ) Main House Front - Right side**

Additional photo of siding and window frame rot.

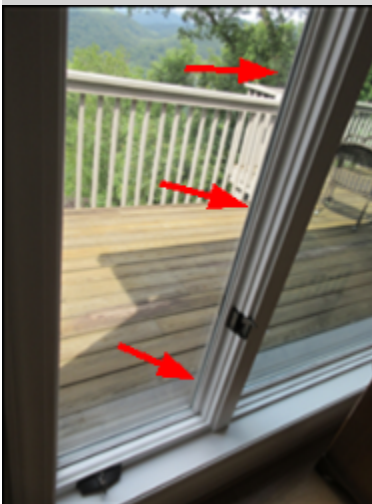
**(B2 - 1.1 ) Windows**

Window painted shut. The window should be capable of being opened. A window specialist should be consulted to open the window and inspect it for any wood damage around the frame and make repairs if needed. See comments below ( Section B2-1 for examples of frame damage.

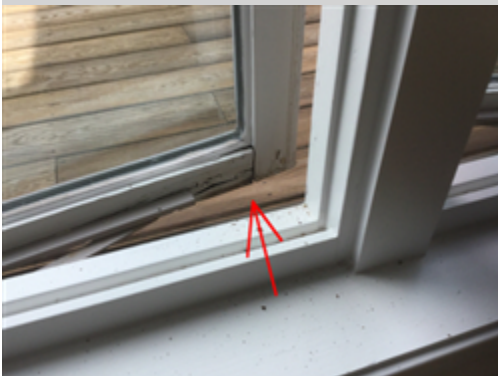
**(B2 - 2.1 ) Windows**

Wood decay was noted behind the exterior cladding of two windows along the right side of the living room. Decay in the windows can result in leaking and water penetration and should be repaired as soon as possible. All windows should be evaluated for damage and or decay as repairs are made. A licensed general contractor should be consulted to evaluate the extent of the damage and to make necessary repairs.

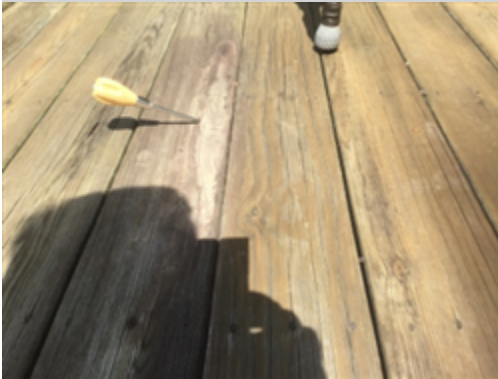
**(B3 - 1.1 ) Deck**

The wood deck was found to be severely weathered. Decking boards were splintering and cupped. The deck should be considered hazardous. A licensed general contractor should be consulted for a complete evaluation of the deck and to make necessary repairs to ensure the stability and durability of the deck.

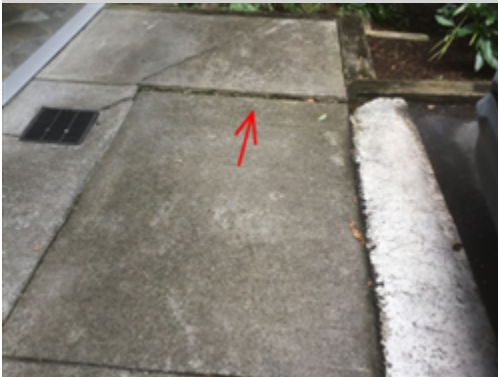
**(B4 - 1.1 ) Driveway**

The driveway is cracked and displaced. The raised section of the driveway has created a path for water penetration under the slab and a trip or fall hazard. A licensed general contractor should be consulted for further evaluation and repair.  
Refer to Section A1-1.3,1.4 for comments on wet foundation in this area of the crawl space front wall.

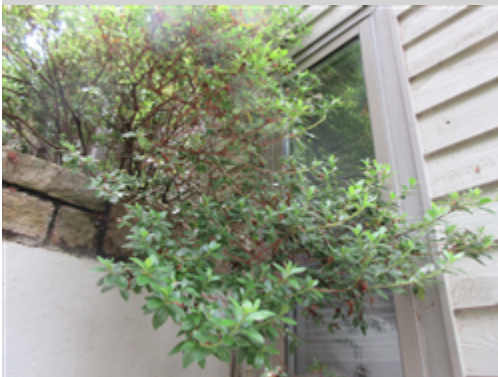
**(B5 - 1.1 ) Vegetation**

The vegetation around this window prevents the window from opening and blocks the air circulation. The growth also limited the inspection access. A landscaping company should be consulted to correct the over growth.

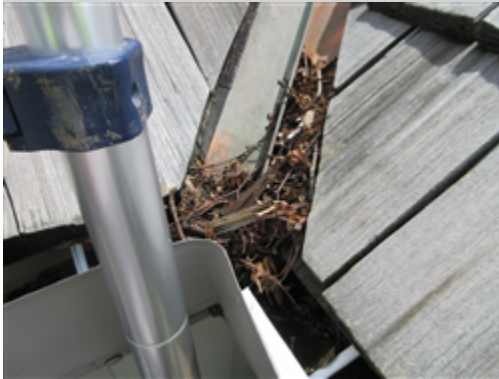
#### **(C1 - 1.1 ) Main House**

Roof appeared to be in good condition visually. the valleys have significant debris. Debris can collect in the downspouts and cause blockage and inhibit the function of the gutter causing water to spill over. Direct drainage to the foundation and cladding from the gutter system can result in water penetration into the foundation area and foundation deterioration. A gutter repair specialist or general repair specialist should be consulted for a complete evaluation and to make necessary repairs.  
See Additional photo below.

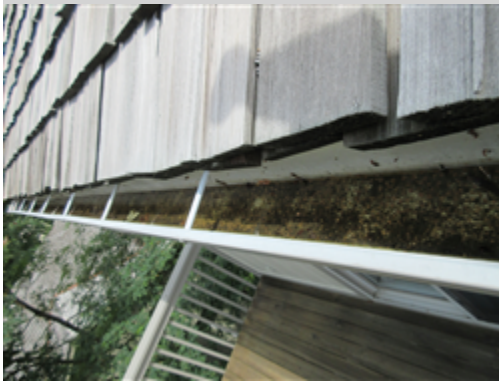
#### **(C2 - 1.1 ) Main House -rear right**

Standing water was noted in the gutter trays in several locations. This indicates that the gutters are not draining and could indicate improper tray slope, a clogged exits, or downspout extension. Direct drainage to the foundation and cladding from the gutter system can result in water penetration into the foundation area and foundation deterioration. A licensed general contractor should be consulted for a complete evaluation of the gutter system to reduce overflow and to make necessary repairs.

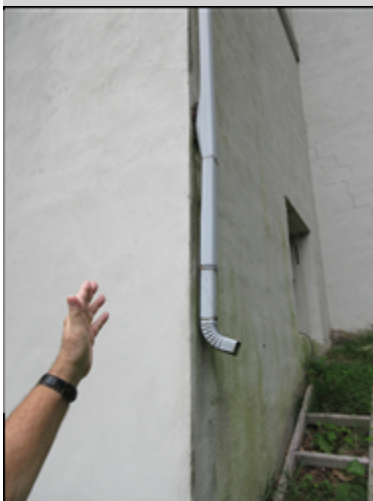
#### **(C2 - 2.1 ) Main House - rear left**

Gutter has a split seam and full of debris. The gutter is high off the ground and not directing water away from the foundation.

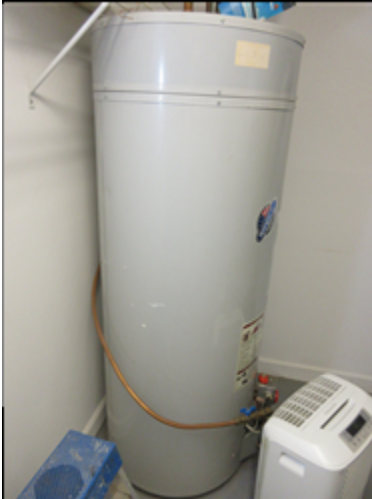
**(D3 - 1.1 ) Unit 1**

Bradford White 75 gallon propane gas water heater  
Model: MIITW756CXB  
S/N: NE6697023  
Date: May 1996

Typically, water heaters have a useful life span of 12 - 14 years before entering into end of life phase. This unit is 23 years old and the top of the water heater show evidence of corrosion and heat (see photo below) . This could indicate back flow of the exhaust. This is hazard that could result in exhaust entering the living spaces of the home and possible carbon monoxide poisoning. A HVAC contractor should be consulted for a complete evaluation and repair of the system to ensure safe, reliable, and proper operation of the water heater.

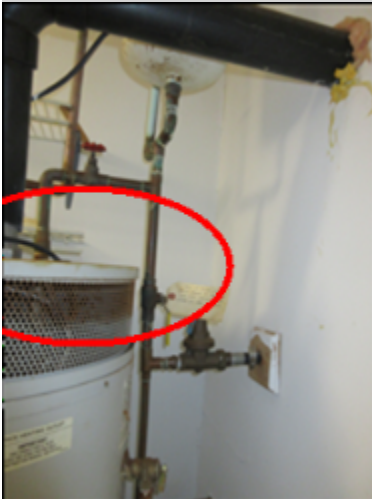
**(D3 - 1.2 ) Unit 1**

photo of rust on to of water heater.

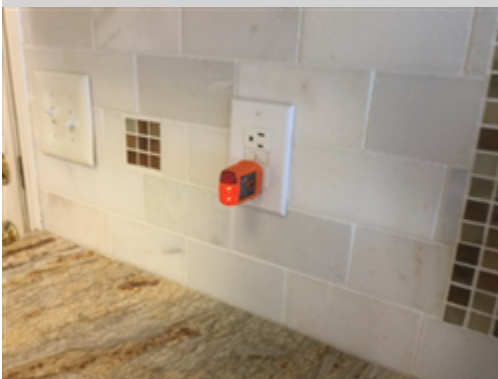
**(E4 - 1.1 ) Kitchen**

The GFCI receptacle for the bathroom/kitchen/exterior/garage did not operate properly when tested. The GFCI is an important safety feature that should be kept functional to reduce shock hazards. A licensed electrical contractor should be consulted for repair.

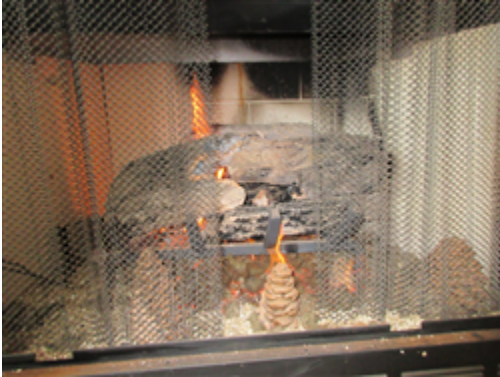
##### (E5 - 1.1 ) Interior

All homes with gas appliances should have a carbon monoxide detector installed to detect improper appliance operation and prevent possible carbon monoxide poisoning. It is recommended that a CO detector be installed for each section of the home in locations as outlined by manufacturer's recommendations.

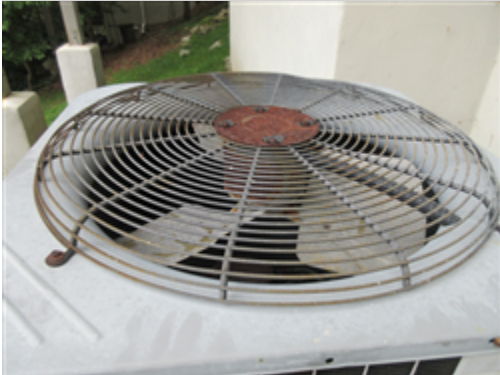
##### (G1 - 1.1 ) Cooling Unit 1

Carrier Heat Pump  
Model: 38CKB060300  
S/N: 2896E20052  
Date: July 1996

Thermostat reduced 2 degrees below room ambient temperature and the heat pump produced cool air at the registers on both levels. Vent fan showing signs of rust. An HVAC specialist should be consulted to check the unit for estimate of remaining useful life.

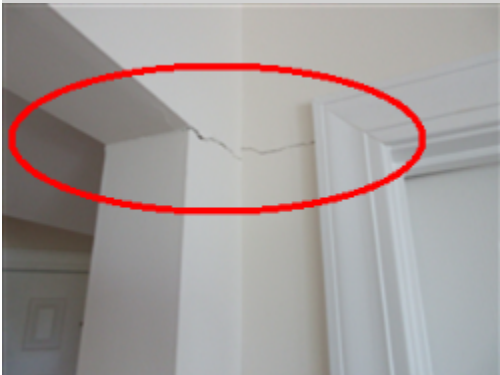
##### (H1 - 1.1 ) Family Room down stairs

The wall is cracked. The crack size and length was more than would be typically expected. An engineer should be consulted to evaluate the structure of the home to determine the significance of this concern and if repairs are necessary.

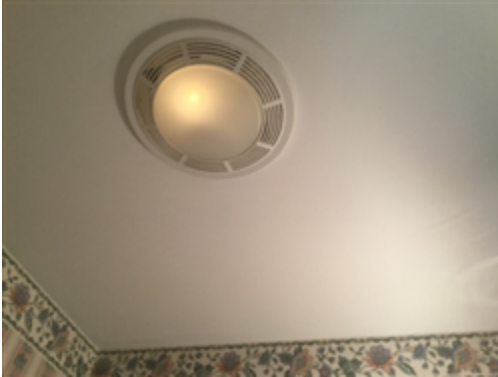
##### (H3 - 1.1 ) Half Bathroom 1

The ventilation fan vibrates and was loud when turned on. The fan needs repair/replacement.

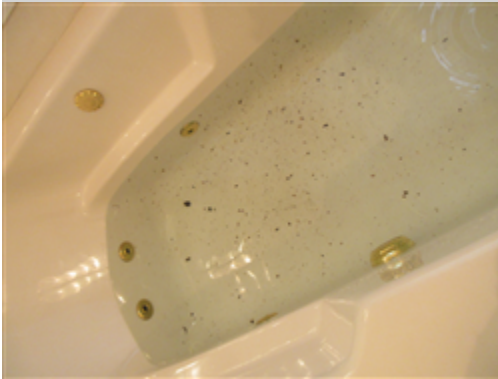
##### (H3 - 2.1 ) Bathroom: Master

Black debris typical of fungal growths exited the jets and entered the water when the whirlpool jets were operated. The tub jets and pump system should be cleaned and sanitized. A licensed plumbing contractor should be consulted for evaluation and repair.

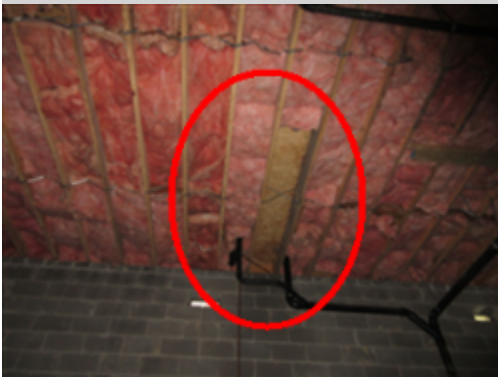
##### (I1 - 1.1 ) Crawl Space: All Accessible Areas

Sections of insulation in the crawl space at the ceiling are not secure and have fallen down. Improper insulation installation could result in condensation, over heating of the building components, and inadequate conditioning of the living areas. A licensed general contractor or a basement contractor should be consulted for repair/replacement.

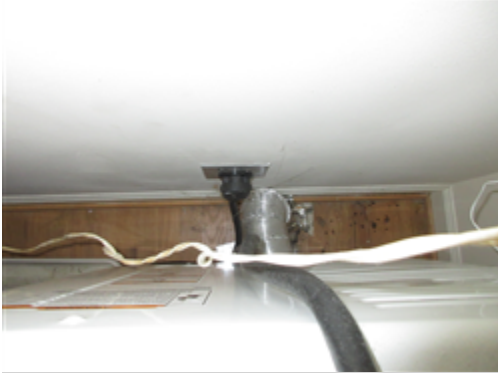
**(J1 - 6.1 ) Vent: Dryer**

The dryer has a flexible metal pipe attached and the vent is ported to the crawl space. See comment below.

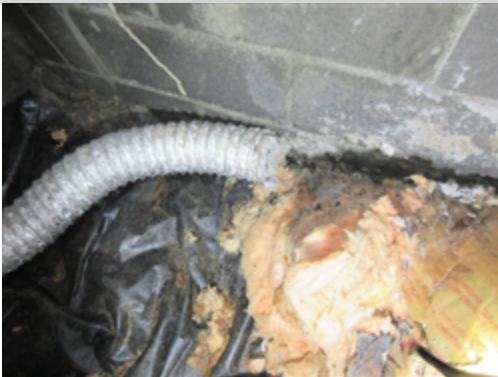
**(J1 - 6.2 ) Vent: Dryer**

Dryer vent laying on the floor of the crawl space. Dryer vents should be ported to the outside of the home to prevent moisture buildup in the crawl space. Lint build up was noted at the exit location which could result in improper operation of the dryer and a fire hazard. A licensed HVAC contractor should be consulted for a complete evaluation of the duct system and to make necessary repairs to ensure reliable and safe operation.
